Identification of weak turbine parts - Kaplan

In the turbine under consideration, there is an abrupt increase of erosion rate at a higher loading degree.

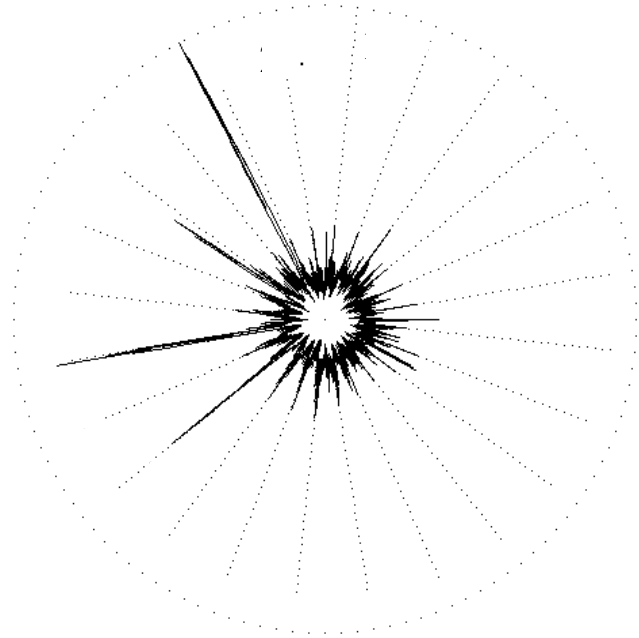
The polar diagram shows the dependence of cavitation intensity on the instantaneous runner's position, recorded at high loading, where the strong mechanism is acting.

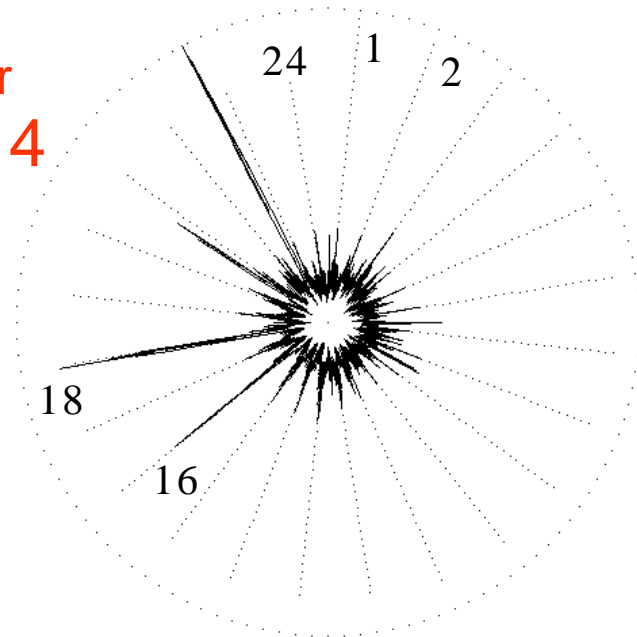
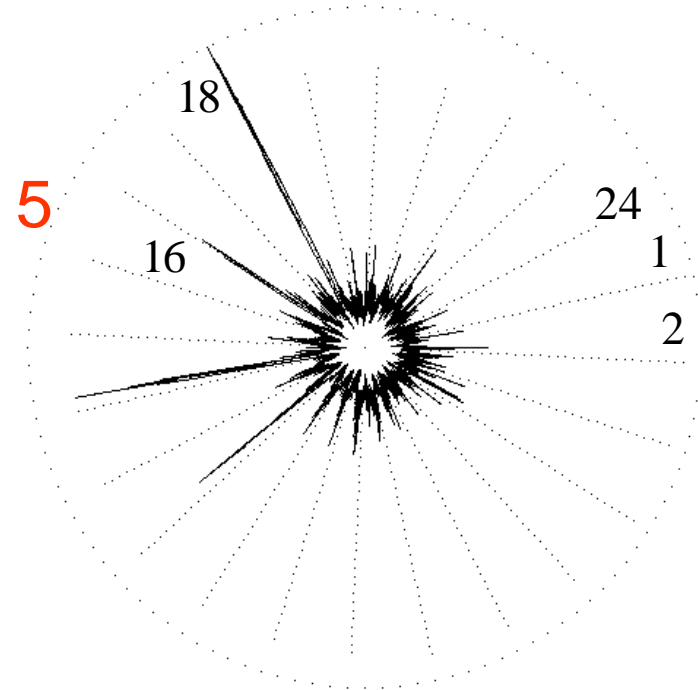
The two diagrams show the positions in which the denoted runner blades interfere with the denoted guide vanes.

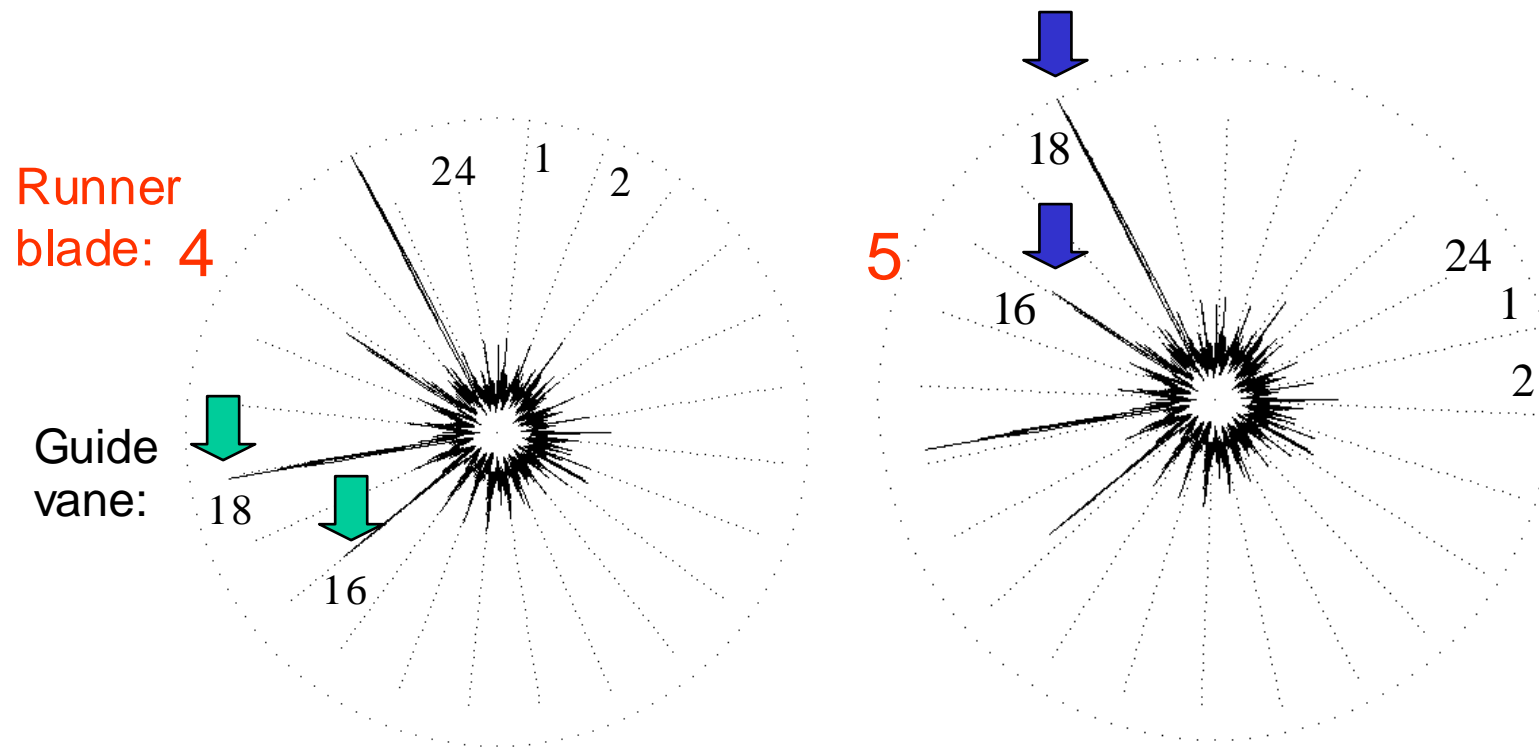
The peaks indicated by

correspond to runner blade 4 and guide vanes 16 and 18, and the peaks indicated by

correspond to runner blade 5 and the same guide vanes, 16 and 18.

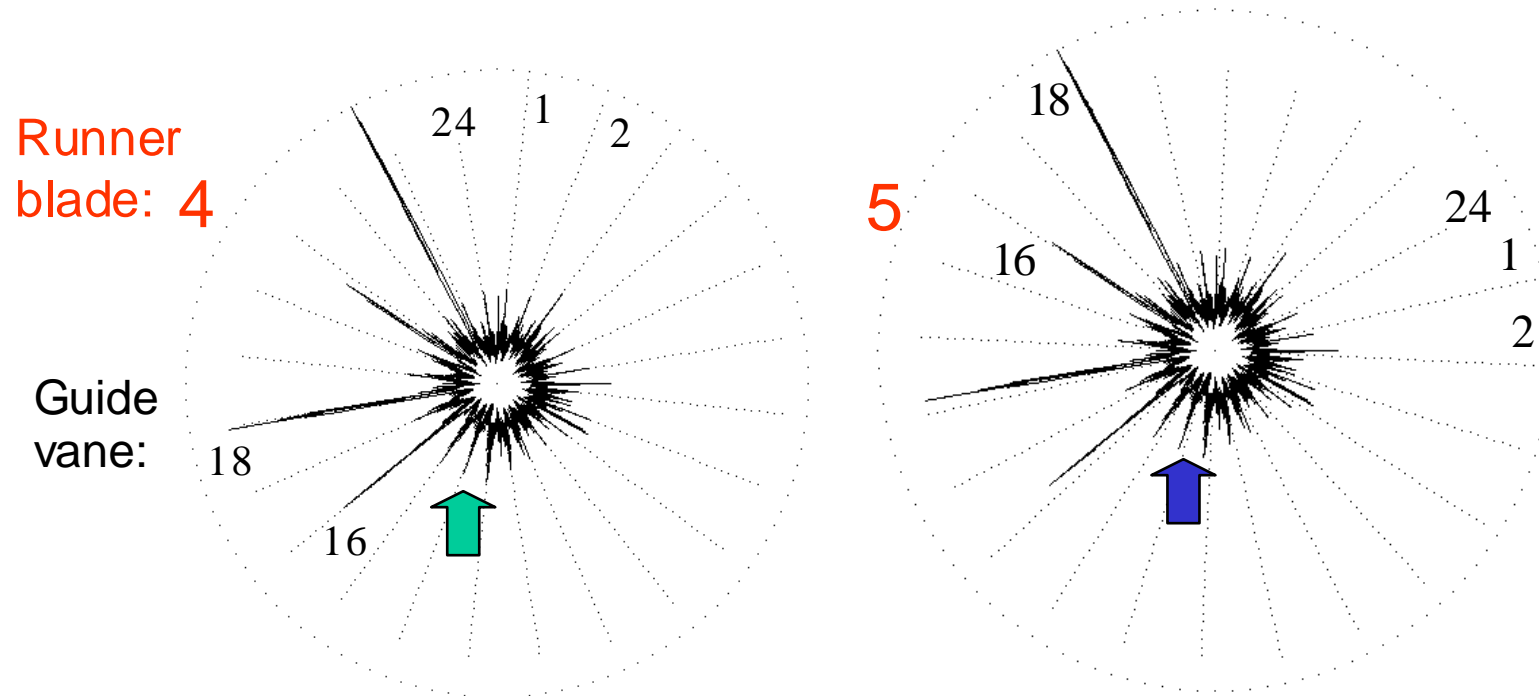
Almost all small peaks coincide with the runner blade 4 diagram, and none with the one of blade 5. There are small peaks at all the guide-vane directions related to blade 4.

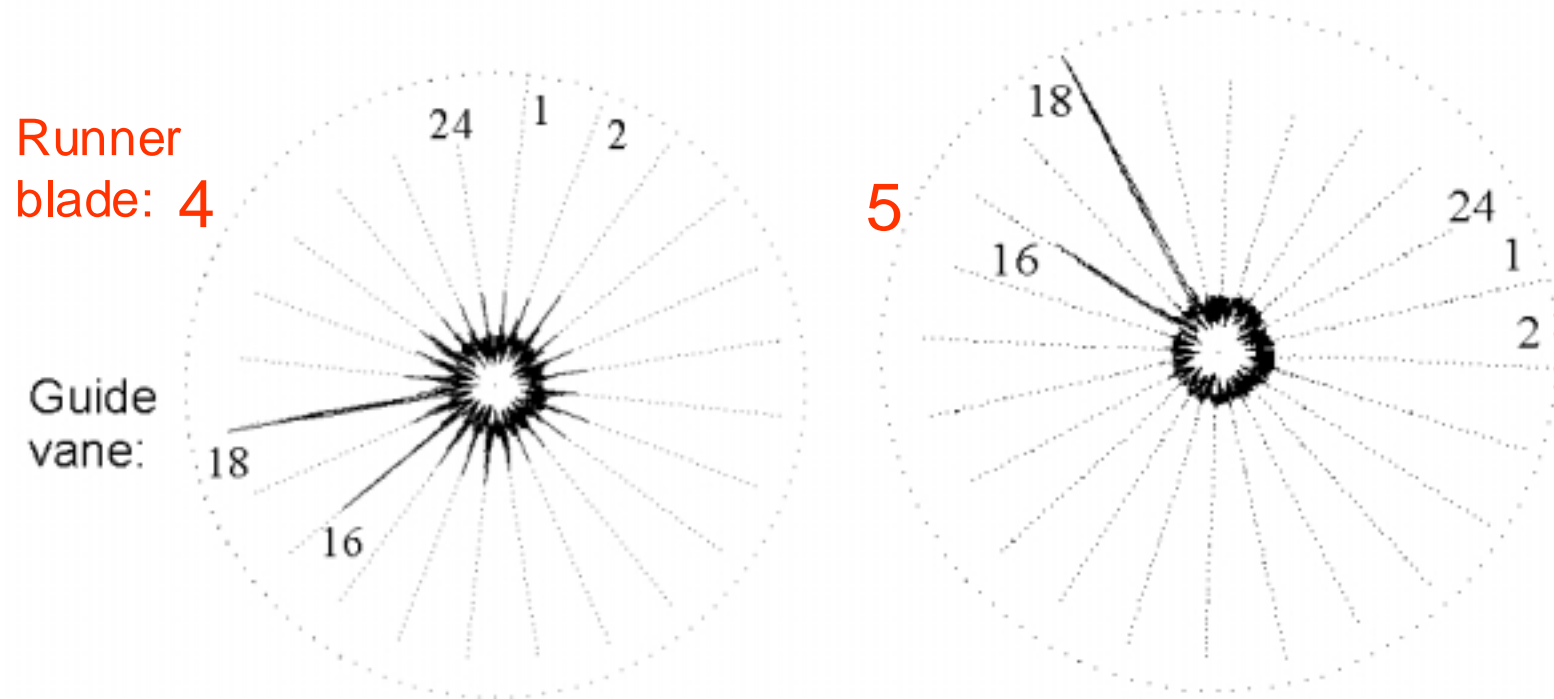
All this shows that the entire pattern can be divided into two additive patterns, which are pure results of cavitation close to runner blade 4 and 5.

Since the two components, related to runner blades 4 and 5, exhaust the total pattern, these are the only blades that cavitate strongly. Both blades do so only behind two guide vanes, 16 and 18; blade 4 also cavitates weakly behind all other guide vanes.
